Manhole Inspection Summary

Manhole # S29OO1002MH

Insp Date: **7/2/07 12:55 PM**

Location Address: **4614 WILMSLOW RD**

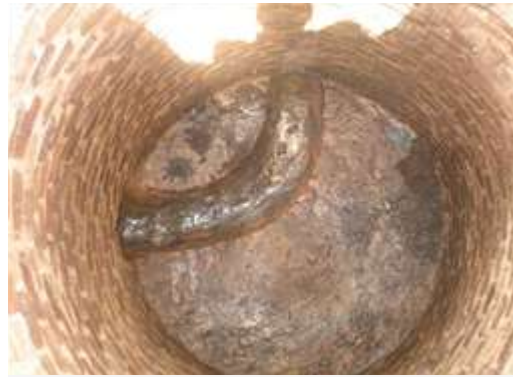
Top View

Evidence of surcharge - Bench debris.
Channel debris.

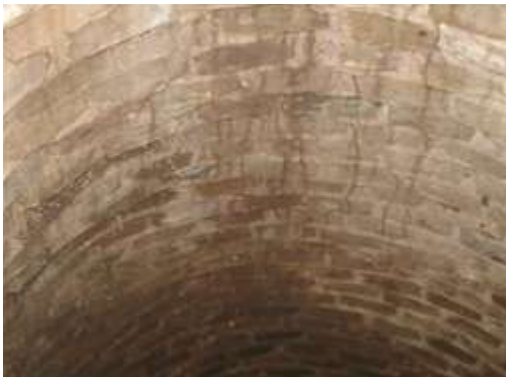
Defect

Adjustment, Corbel and Barrel infiltration.

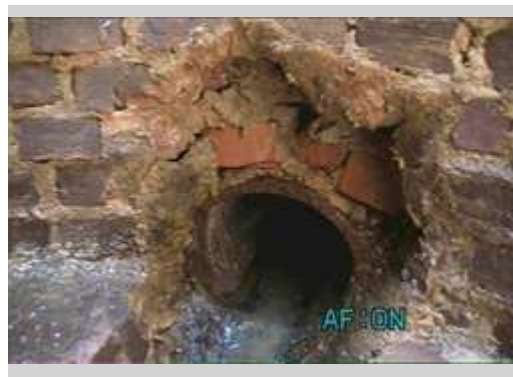
Defect

Barrel deterioration and infiltration.

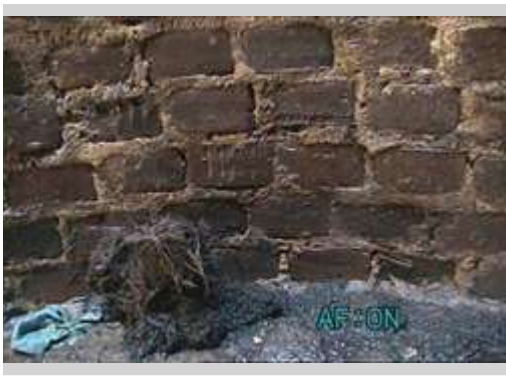
Defect

Barrel root intrusion and infiltration..

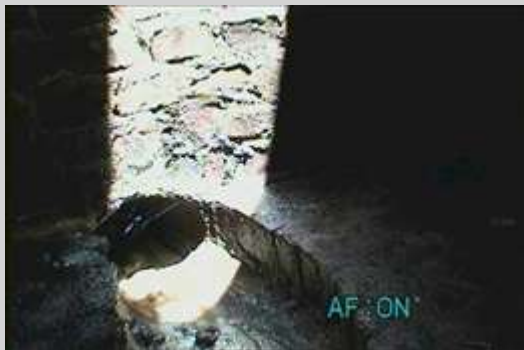
8 in. Circular Gravity Sewer Pipe Out @ 12 O'Clock

Deposits: ☐ None ☒ **Mud** ☐ Sludge ☒ **Debris** ☐ Grease

Silt Depth: **0** (in.) Deposits Extent: **Light**

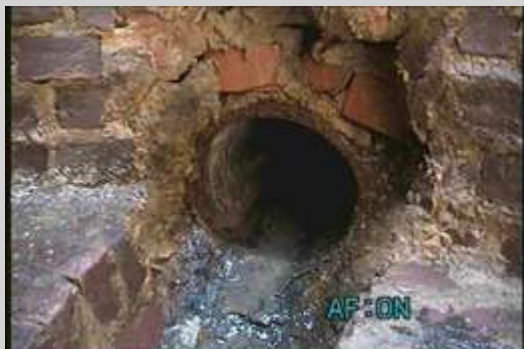
8 in. Circular Gravity Sewer Pipe In @ 9 O'Clock

Infiltration: **Evidence** Pipe Seal Cond: **Broken**
